Geotechnical Assessment Report

**Delta Small Communities Flood Risk
Reduction Program – Community of Isleton**
Sacramento County, California

GEI Consultants, Inc.

May 2022

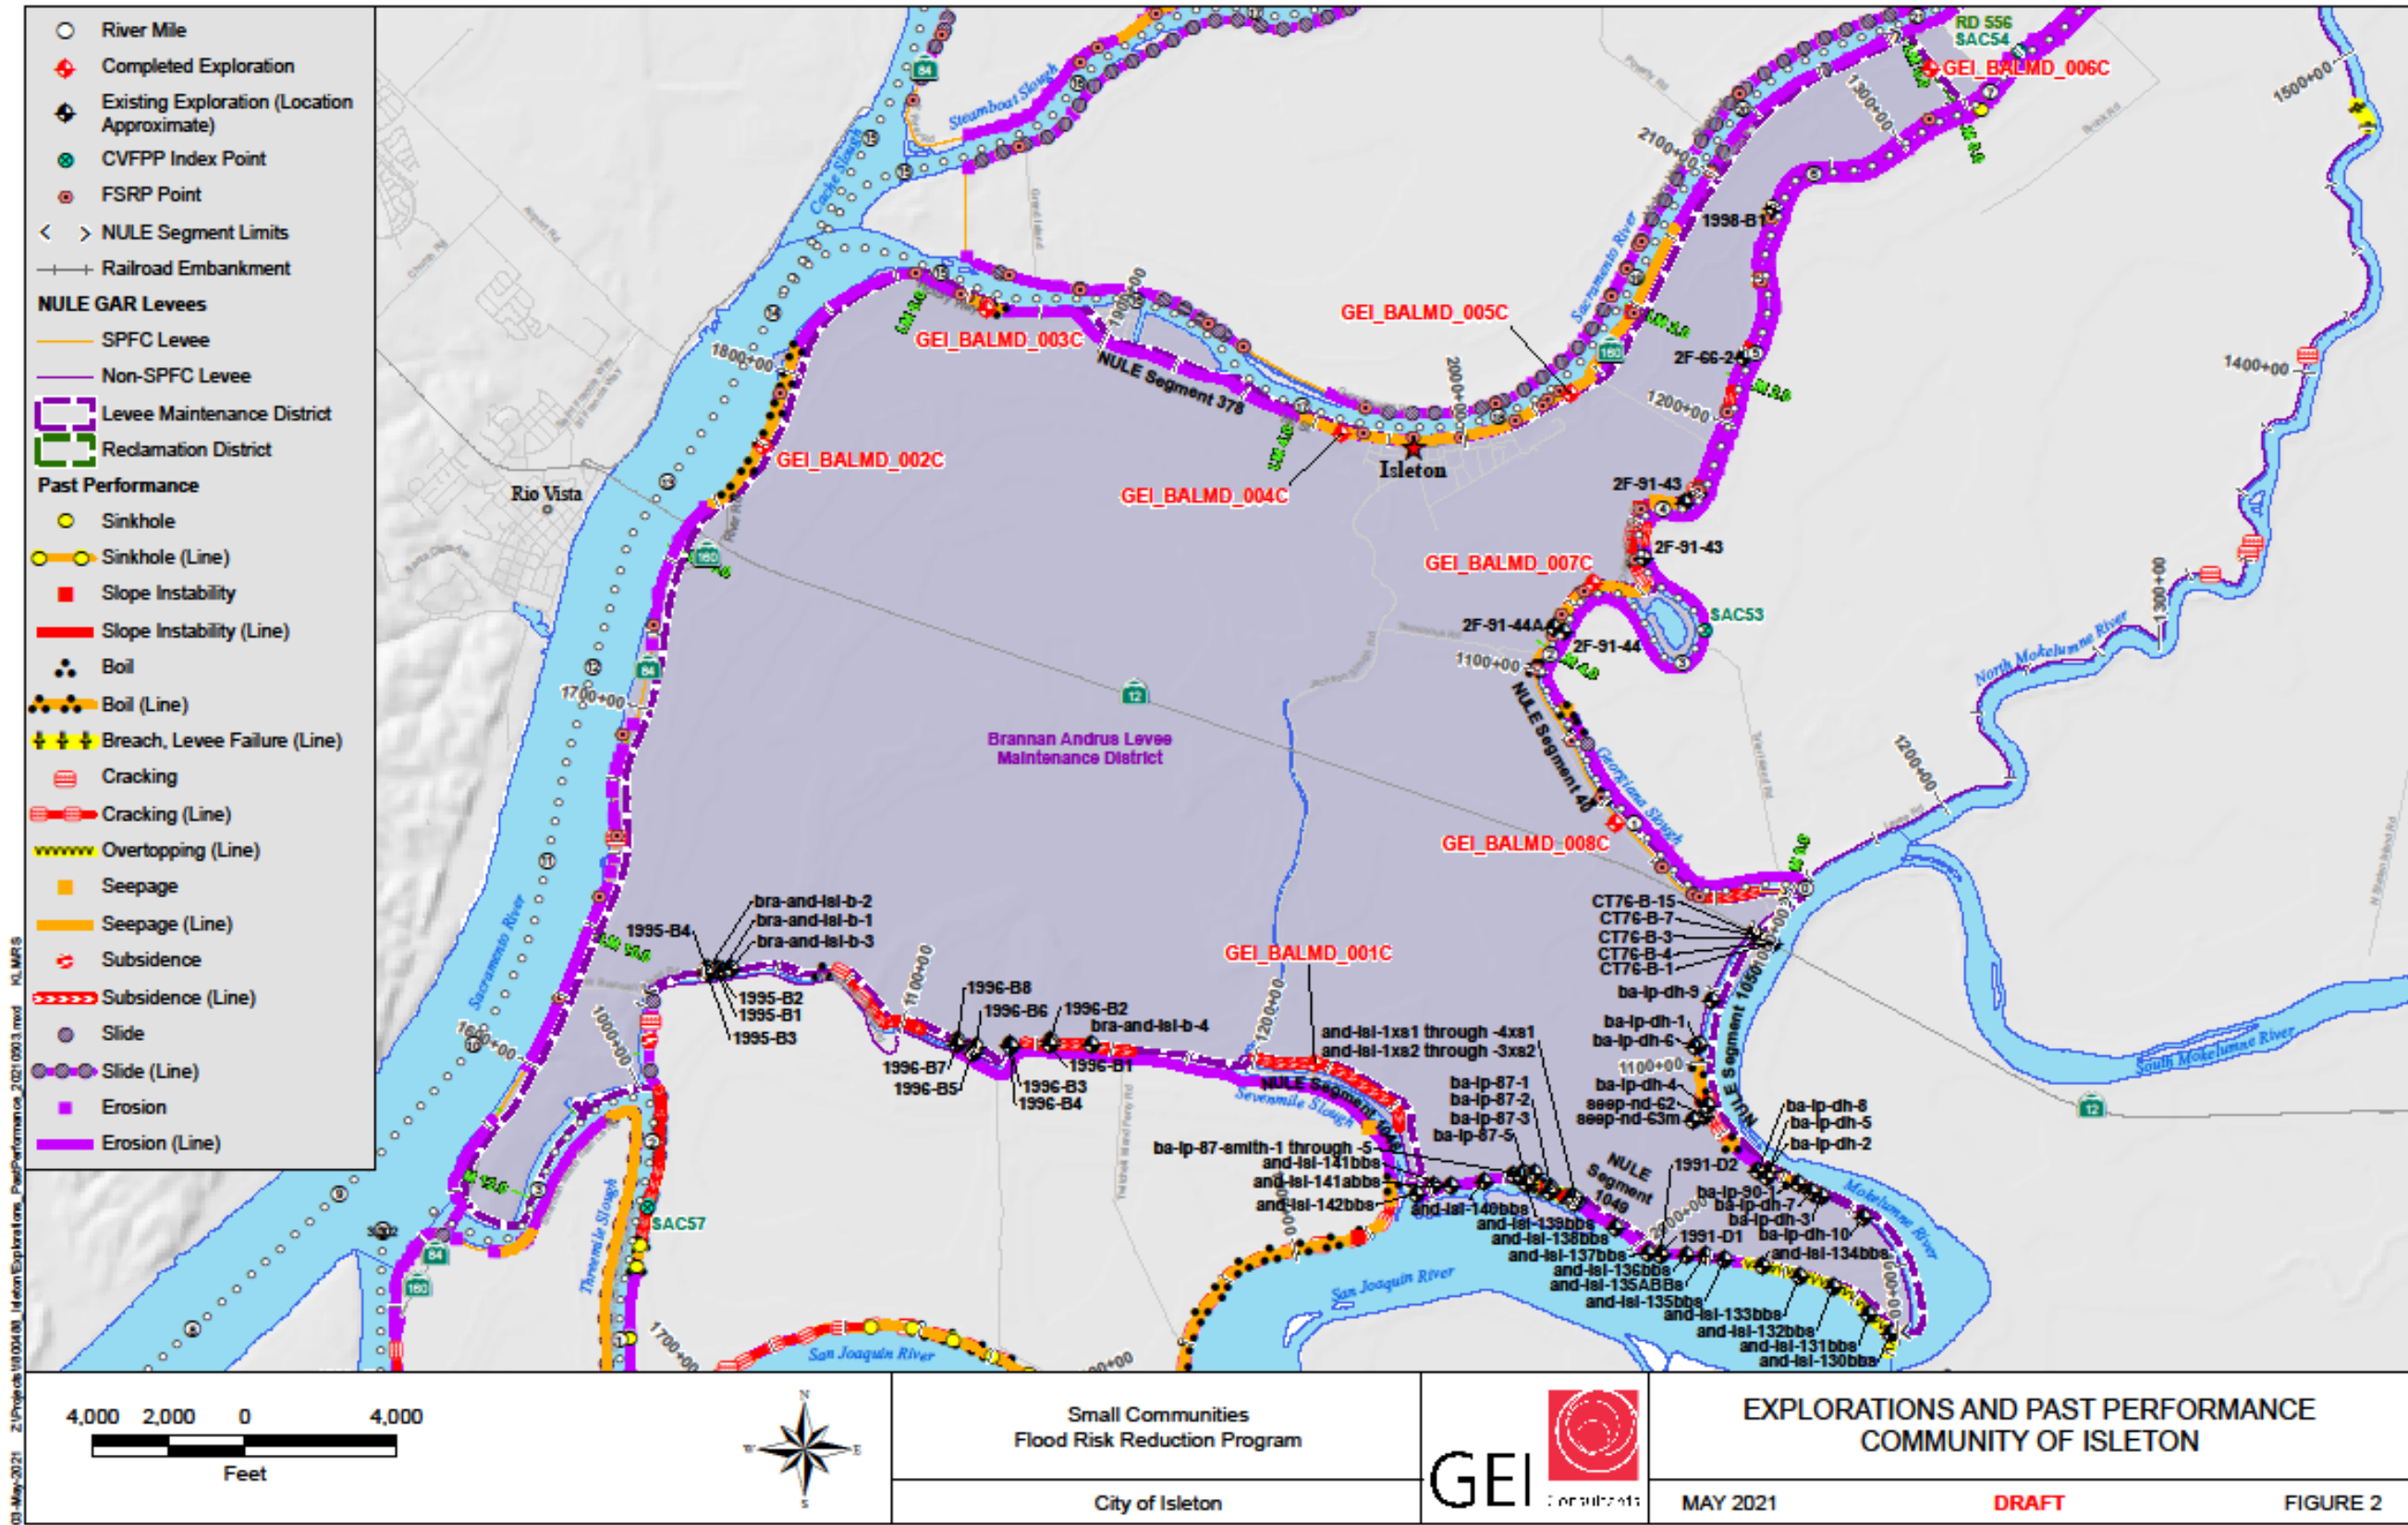
Figure 2 Explorations and Past Performance Community of Isleton

Past performance is based primarily on the DWR NULE project information which was gathered through review of available documents and interviews with levee maintenance personnel. In general, the Sacramento River levee near the City of Isleton has experienced widespread erosion including bank and slope caving and wavewash erosion. Limited occurrences of cracking and landslide sloughing have also been reported. For the remainder of the BALMD basin (NULE Segments 40, 1050, 1049, and 1048) boils and seepage have been reported during past high-water events. Particularly several reports of seepage, boils, or boils moving sand are documented along the levee to the southeast of Isleton, near Oxbow Marina (NULE Segment 40) in the 1996-97 and 1997-98 high water events. Occurrences of slope instability, subsidence, cracks, and settlement are also noted at locations throughout the basin.

Based on past performance and field reconnaissance, DWR's Flood System Repair Project (FSRP) identified two *critical* sites along the levees of the BALMD basin, one for through

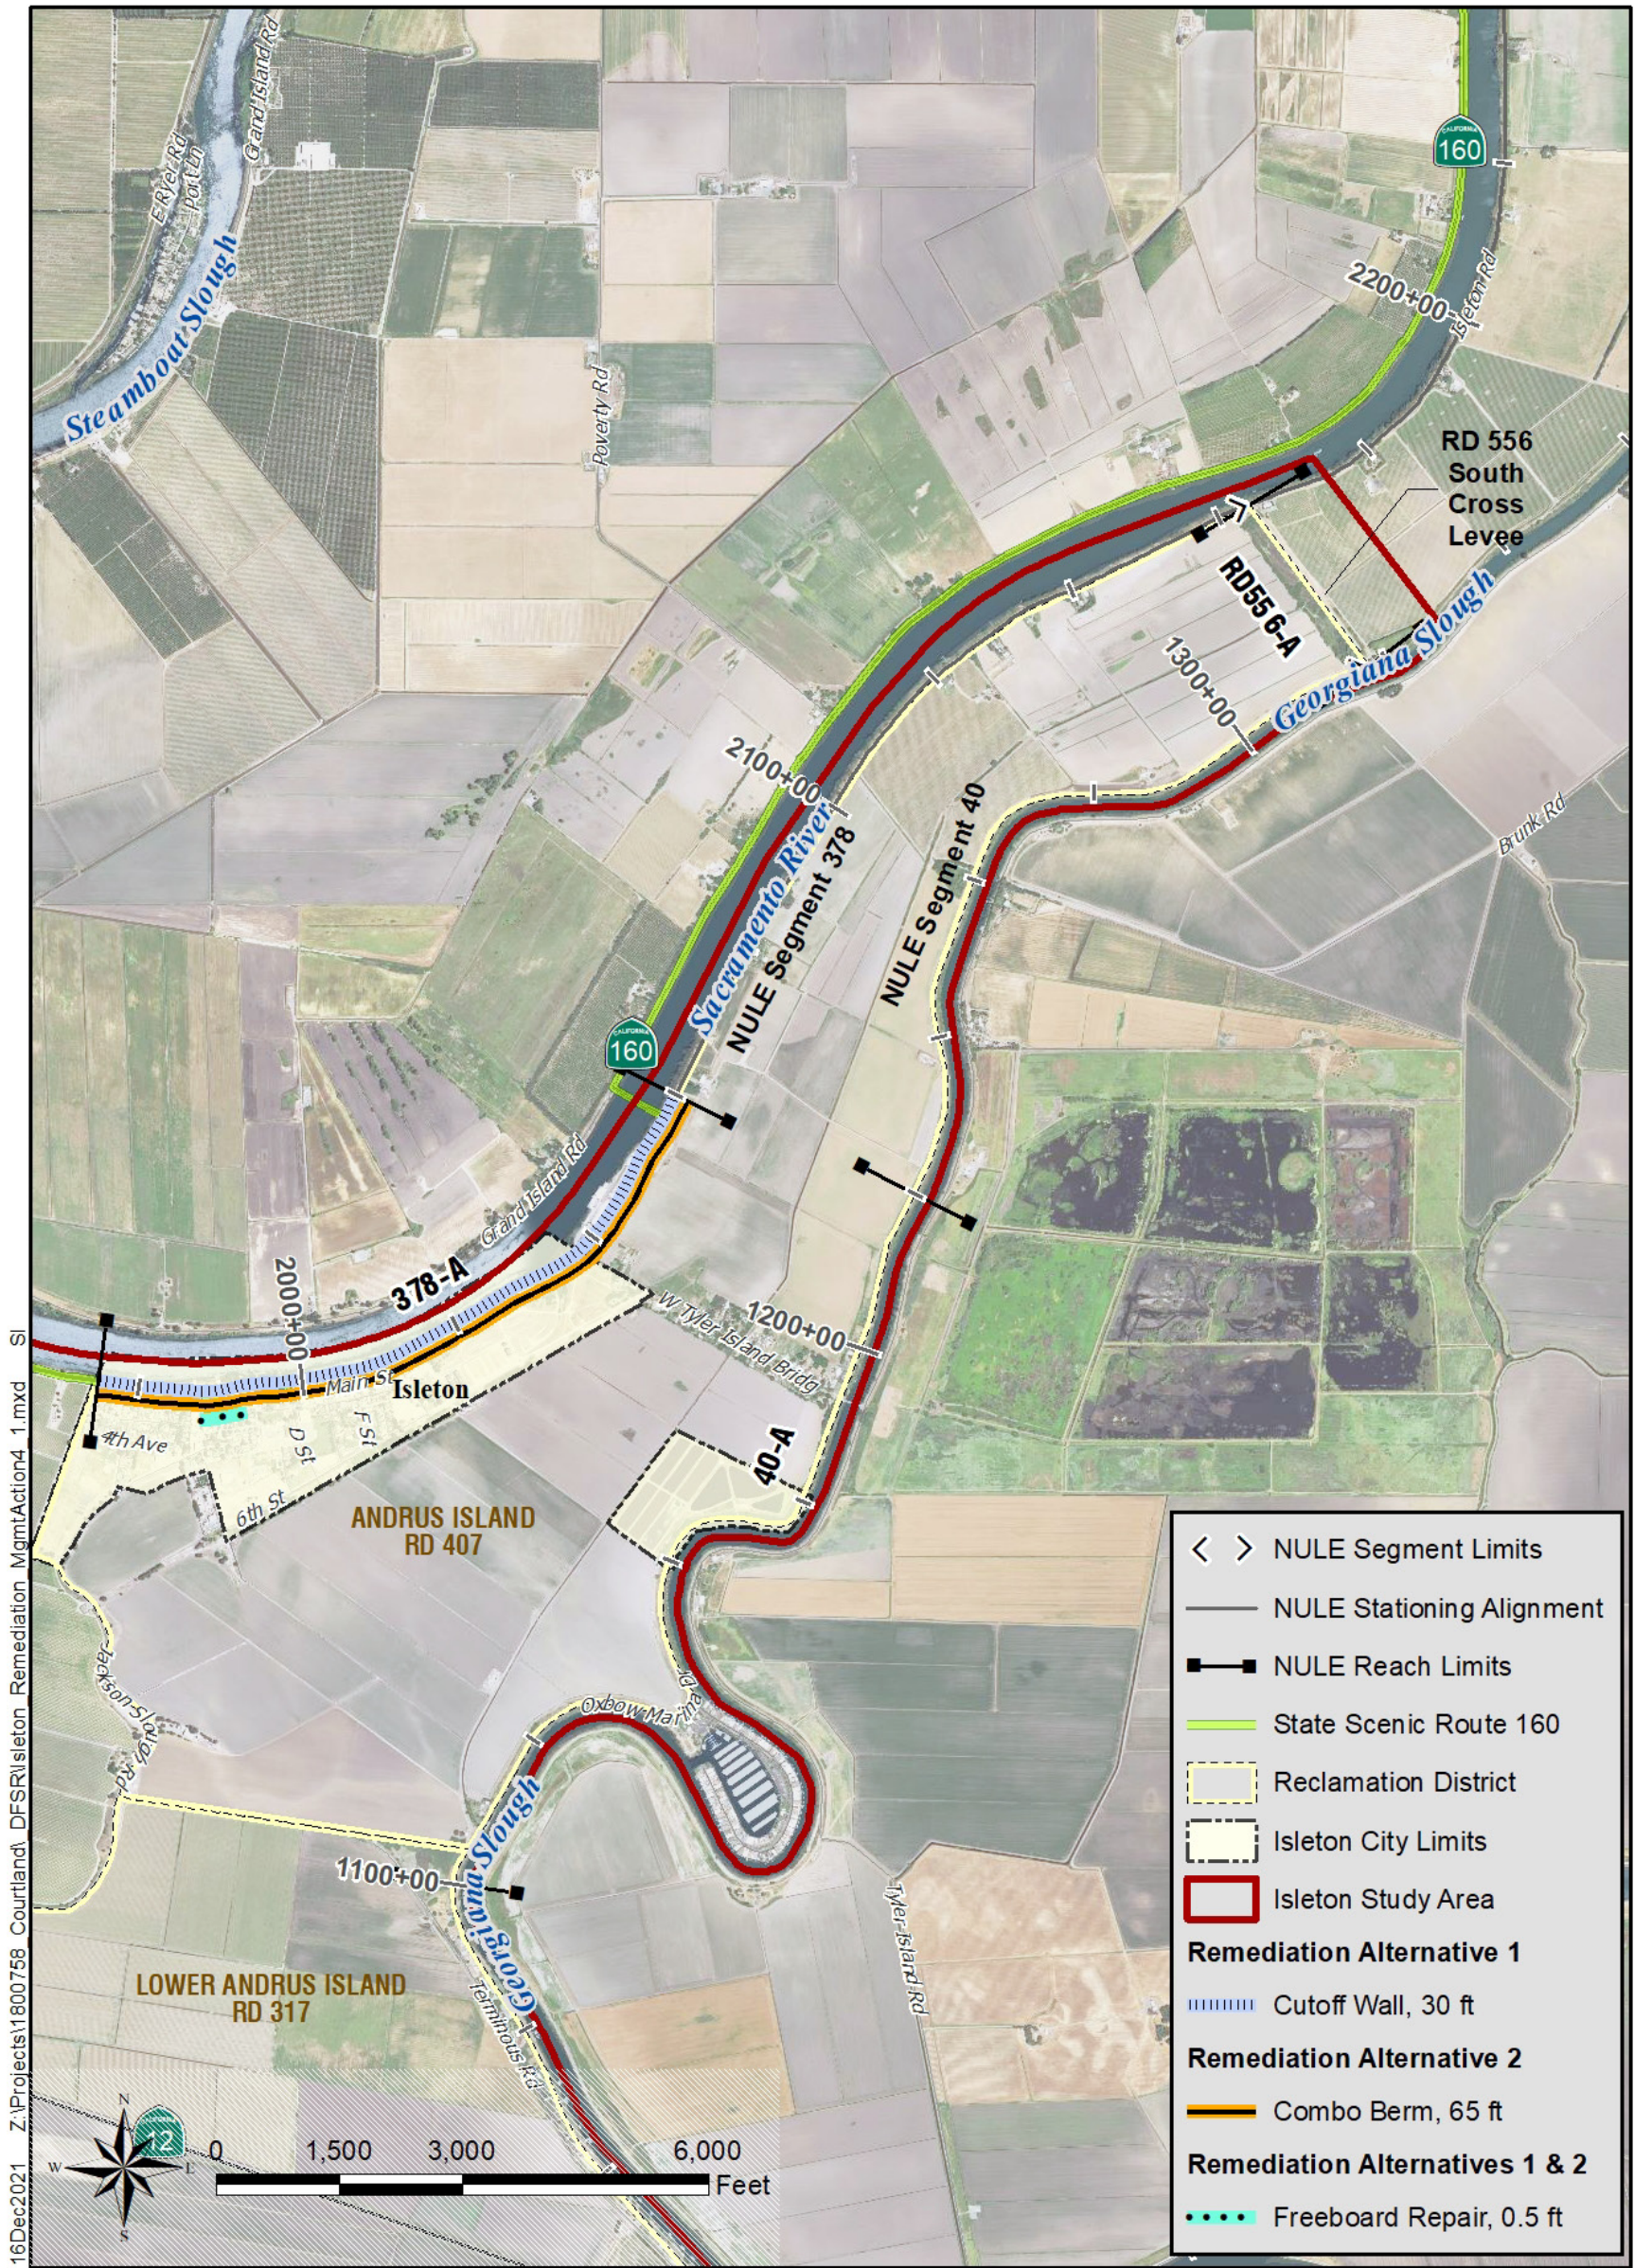
Figure 7 Repair and Strengthen-in-Place Remedial Alternatives for Sacramento River Left Bank SPFC Levee Adjoining Isleton (Portion of NULE Segment 378)

The assessment also found that the entire reach has insufficient freeboard for the AWSE. The levee is deficient in freeboard by an average of 1.5 feet along this reach.
