Geotechnical Assessment Report

**Delta Small Communities Flood Risk
Reduction Program – Community of Isleton**
Sacramento County, California

GEI Consultants, Inc.

May 2022

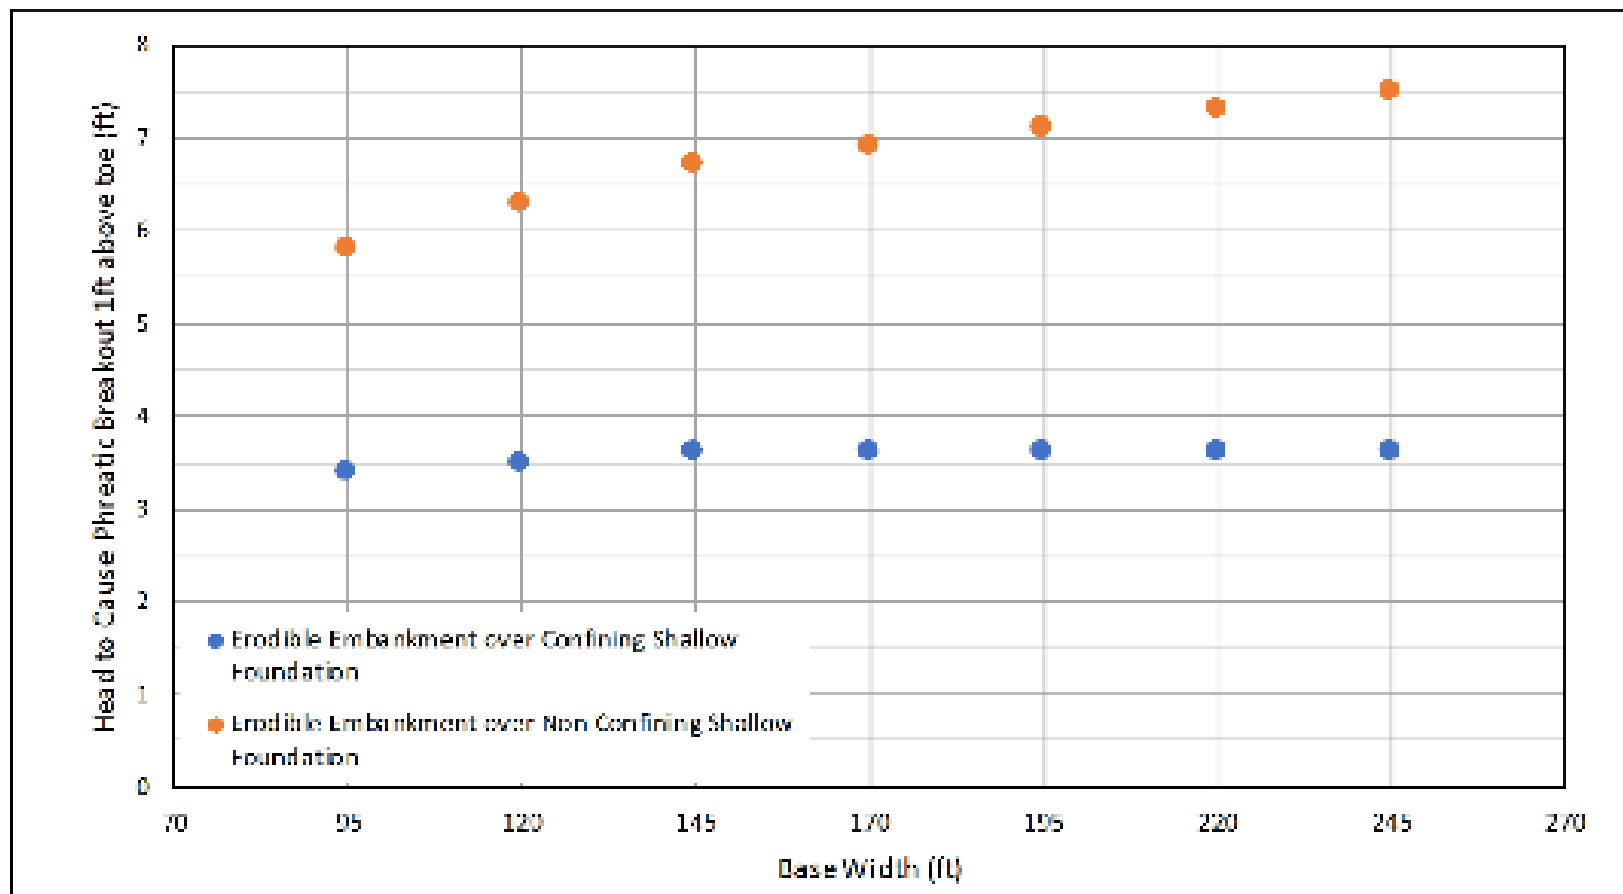
Figure 5 Through Seepage Criteria Analysis Cases

CRITERIA SUMMARY		Levee Base Width (feet)						
Analysis Case	Fmh./Found.	95	120	145	170	195	220	245
		Head to Cause Through Seepage						
1	Erodible Embankment over Confining Shallow Foundation	3.4	3.5	3.6	3.6	3.6	3.6	3.6
2	Erodible Embankment over Non-Confining Shallow Foundation	5.8	6.3	6.7	6.9	7.1	7.3	7.5
